PCN# 20121221001

Fix unstable operation with PLLM at 600 MHz on

MityDSP-6711 Family of System On Modules

Date: December 21, 2012 To: Purchasing Agents

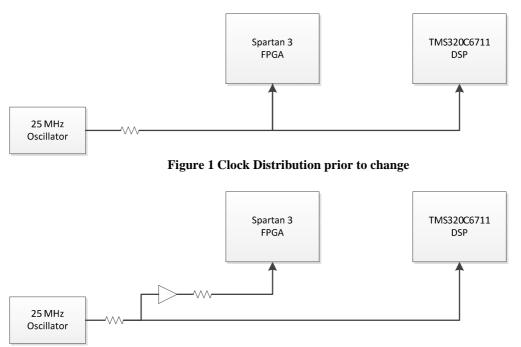
Figure 2 Clock Distribution with change applied

The distribution of the on-board 25 MHz oscillator clock to the FPGA and DSP was changed from what is shown in Figure 1 to that shown in Figure 2.

Recent production runs of MityDSP-6711 and MityDSP-6711 XM processors exhibited instability in the processor phase locked loop circuit. The instability presented as a rapid shift in processor clock frequency (the PLLM output) for approximately 1 to 2 microseconds, long enough to cause the FPGA digital clock manager (DCM) conditioning the EMIFA clock to break lock. This resulted in errors in communication between the DSP and the FPGA on the module.

The root cause of this issue was determined to be a combination of a suboptimal design (the 25 MHz clock source net was bifurcated, feeding both the FPGA and the DSP) and a change in the DSP manufacturing process (the clock input pin

bandwidth increased in sensitivity to as high as 4 GHz) as well as production variances in the FPGA clock input impedance.

By isolating the clock paths as shown in Figure 2, the instability due to reflections in the split clock net was removed.

Prior to hardware modification, a work around was identified that greatly reduced the occurrence of this issue. The default PLLM setting was 600 MHz. This frequency was divided down to develop the system CPU clock and EMIFA clock. By using a lower PLLM setting such as 400 MHz via a Critical Link provided software function the issue was, in many cases, resolved.
